Mutual Aid is Key

Presentation to CUEA

June 13, 2019

Carr Fire - July 2018

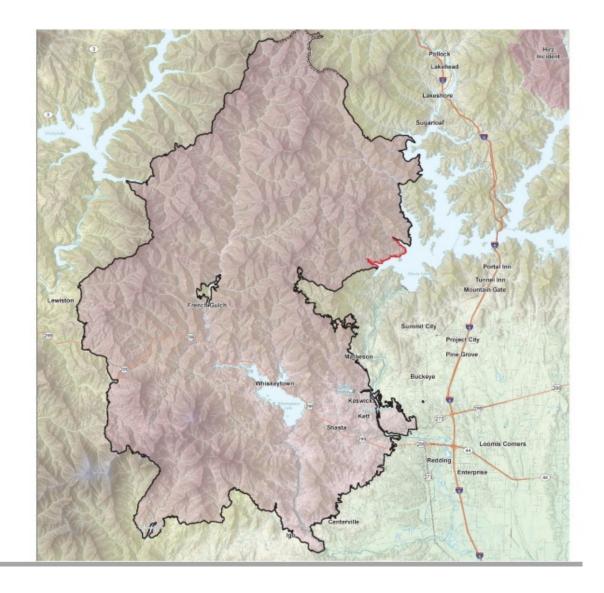
Carr Fire Map

- Began July 23, Fire hit Redding July 26
- 359 Square miles burned in total
- 1079 Homes Lost County
- 265 Homes Lost Redding
- 8th most destructive in Cal history
- Evacuation of City West side, gridlock
- City load maintained by Generation
- Shasta Lake City, black-out

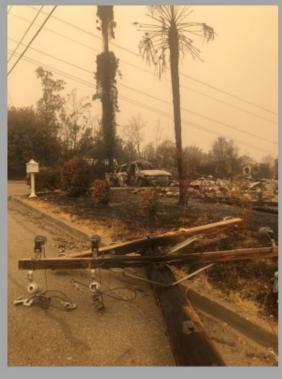
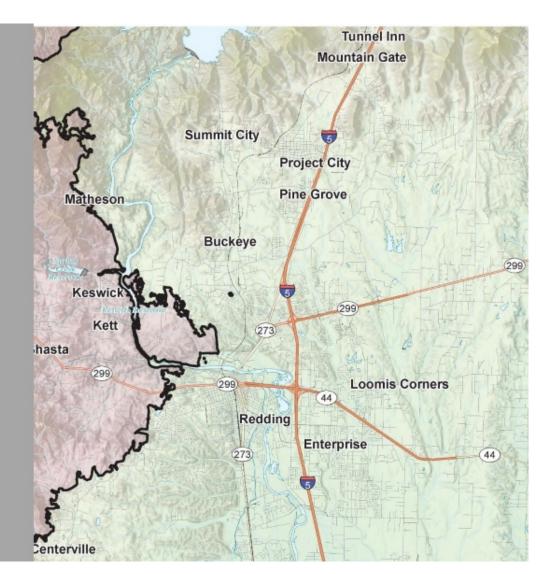
Redding Damage Map

- Lost 12 Miles 115 KV Line
- Lost 12 Mile -12 KV Line
- 270 Power Poles destroyed
- Lost River Crossing Structure at Keswick
- WAPA also Lost 4 transmission lines Keswick Area

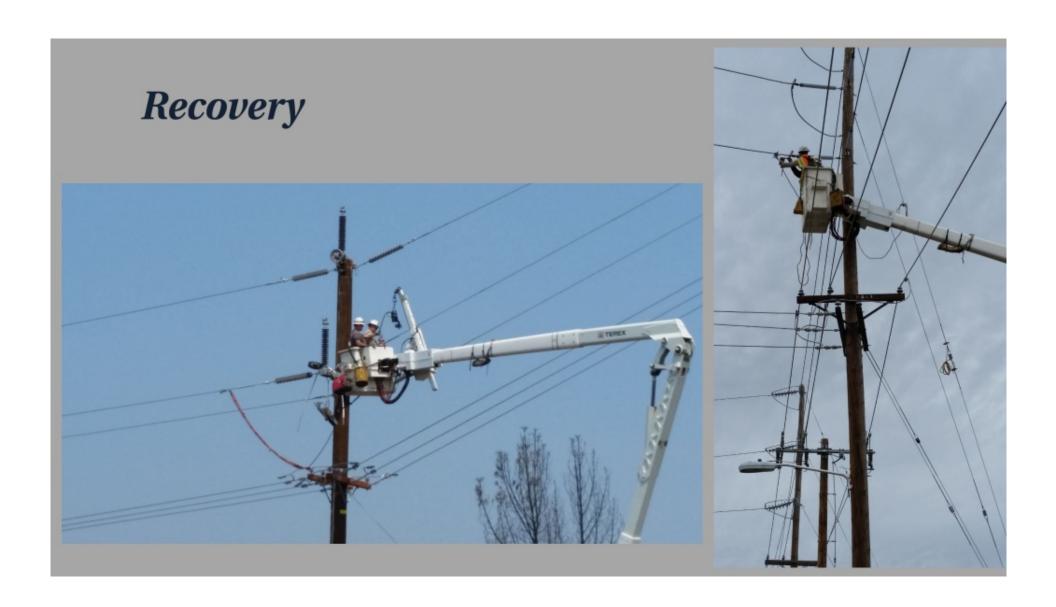
Necessary repair:

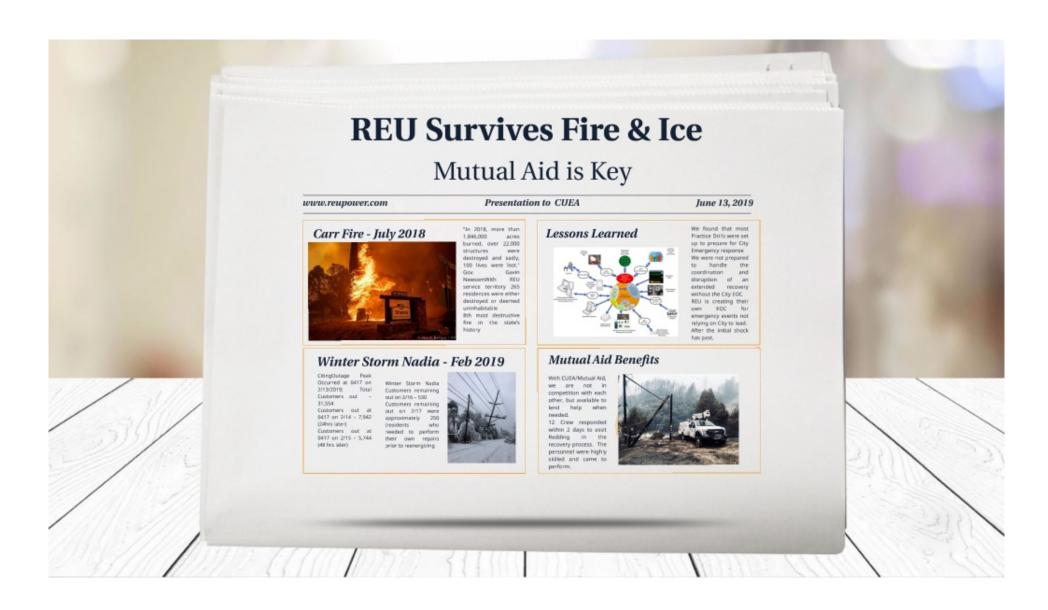
- Day 1 & 2: Gain access and assess damage and priorities
- Day 3: WAPA established 2nd line, Ending Rolling Blackouts
- Week 1: 270 Damage isolate, Partial circuits re-energized
- Week 2: All remaining undamaged services energized
- Week 3: All but one, 115 KV Line fully restored.
- Week 5: System Full Redundancy restored
- Week 6: Whiskeytown Generation plant restored.

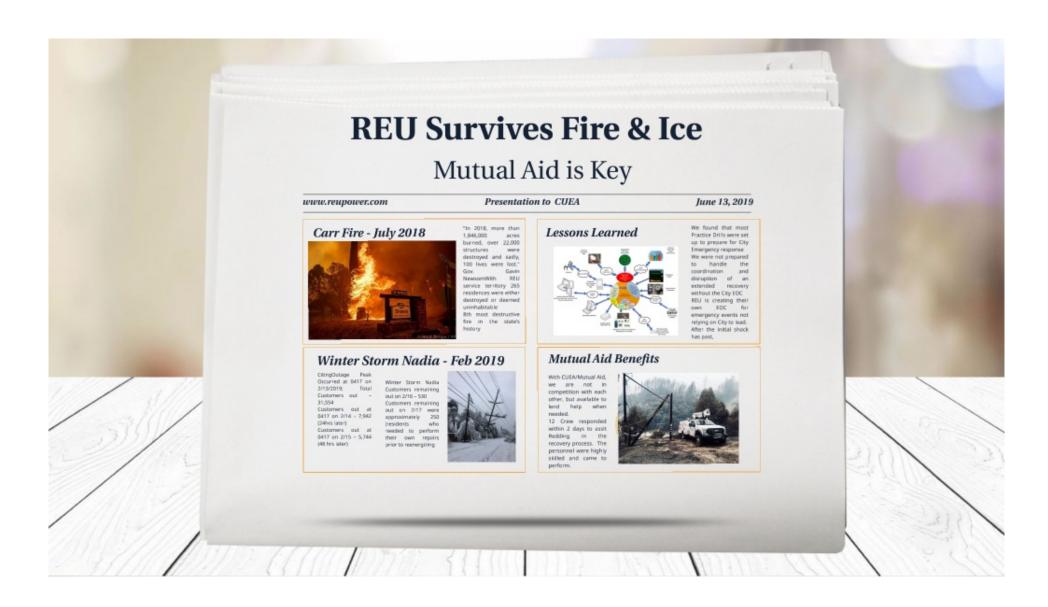
- Outage Peak Occurred at 4 AM on Wed, Feb 13,
 31, 554 Customer outage, 8 Substations Black
- After 1 day 8000 Customers
- After 2 days 5700 Customers,
- · Mutual Aid crews begin arriving
- 3 days later 550 Customers
- 5 days later Less than 300 Customers
- 7 days later Approx 200, with Damaged Services
